CLINICAL CASE

FIONA DAVIS, OCCUPATIONAL THERAPIST HBDHB & MEGAN RANSLEY, SALES AREA MANAGER, PHYSIOTHERAPIST, NZ

Pressure redistribution and stability through immersion on an Adjuster 12.

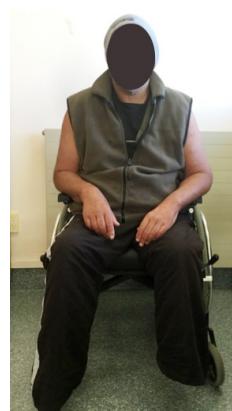
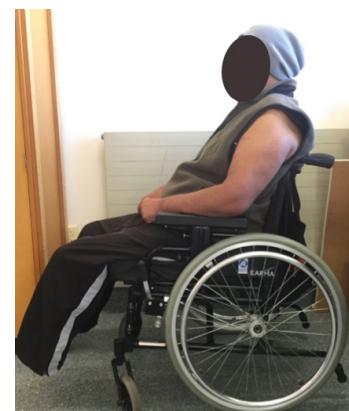
Pressure mapping of the foam cushion demonstrated that Mr. S. was weight bearing significantly through both ITs, but in particular the right with a peak of pressure seen there. It also demonstrated that Mr. S.'s weight was unevenly distributed with almost no weight being taken through the thighs. The picture showed a small surface area of weight bearing. This cushion allowed only one hour of sitting before pain was experienced in the ITs. It is likely that over time the foam was compressing and the cushion's pressure redistribution properties were diminishing.

Pressure mapping was undertaken on all three cushions: a foam cushion, the Vicair Active (9cm) and the Vicair Adjuster 12. Single peak pressures seen over the ITs sitting on the foam cushion were eliminated as the legs could be used as weight bearing surfaces.

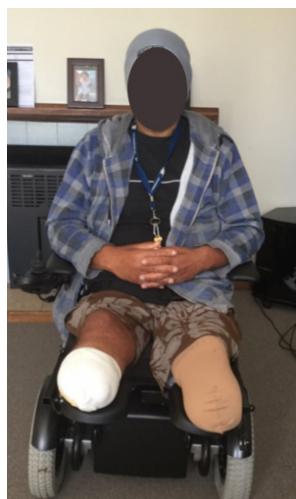
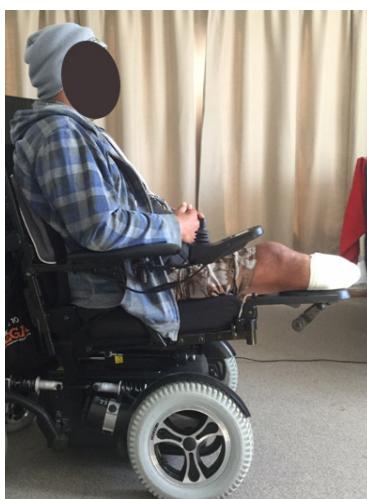
It was thought that the firm front of the Vicair Active 9 would enable safer and easier transfers, while affording the pressure redistribution Mr. S. required. As can be seen from the pressure mapping images, significant improvement was made in relation to the pressure redistribution with a much larger surface area taking weight. This cushion was adjusted by removing 5 cells from both left and right compartment to allow immersion. Mr. S. commented that the cushion felt comfortable and supportive. He sat well with an improved upright posture. He managed to transfer with ease.

Trial of the Vicair Adjuster 12 cushion was carried out as a comparison. Mr. S. immediately commented that this cushion felt even more comfortable. This is likely because of the depth of the cushion. Mr. S. is a heavy man and could immerse deeply into the Adjuster 12 cushion without the need for cells to be removed. This deep immersion afforded a greater surface area over which his weight was distributed, giving even pressure redistribution and the feeling of greater comfort. The greater immersion available from the Vicair Adjuster 12 cushion also enabled Mr. S. to feel more stable within his wheelchair. The pre-ischial bar provided a barrier to the pelvis sliding forward.

The Adjuster 12 provides Mr. S. with high pressure distribution properties that are needed to enable him to sit safely and comfortably all day. The pre-ischial bar prevents him from sliding forward, whilst deep immersion provides stability. Furthermore the cushion is low maintenance and easy to understand. The Vicair Adjuster 12 turned out to be the ideal product choice and solution for Mr. S.

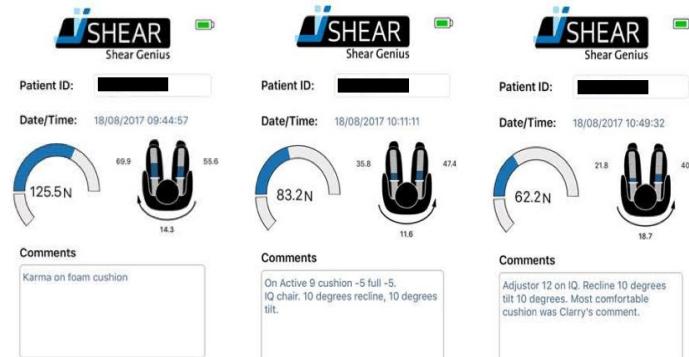
This demonstrated that Mr. S. was experiencing not only downward pressure, but also dangerous forward shearing forces (sliding force). Shear forces were reduced from 125.5N on the foam cushion, to 83.2N on the Active 9 cushion, then to 62.2N on the Adjuster 12 cushion. This demonstrates that Mr. S. was able to sit more upright, with less sliding forward. The reduction in shear force is likely contributing to the preference towards the Adjuster 12 cushion the increased comfort and to improved sitting tolerance.

As Mr. S. indicated the sensation of sliding forward in his initial seating system a shear force assessment was made by using iS-hear.
